ADVANCED PHENOLIC COMPOSITE
TRANSIT VEHICLE FLOOR SYSTEMS:
A REVIEW OF USA ROLLING STOCK VEHICLE
FLOOR FIRE PLATFORM TESTING AND RELATED
PASSENGER SAFETY FIRE PROTECTION

OCTOBER 24, 2012

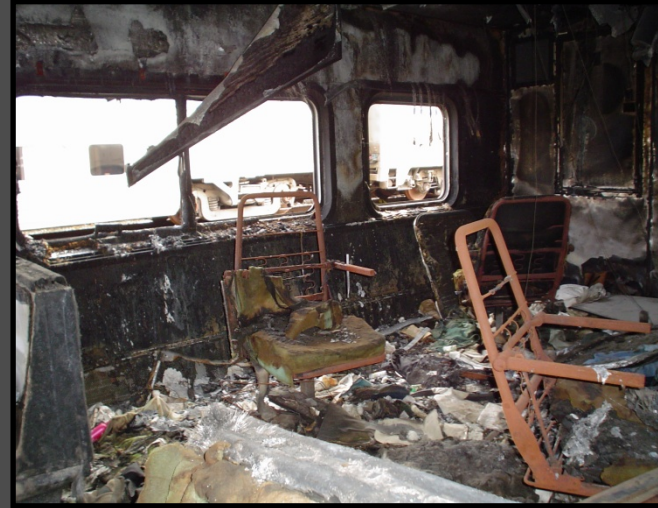
Passenger Interior

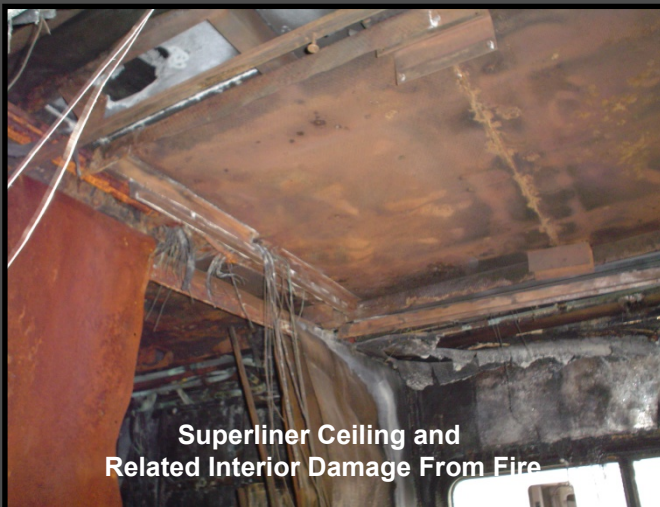
Superliner Ceiling and
Related Interior Damage From Fire

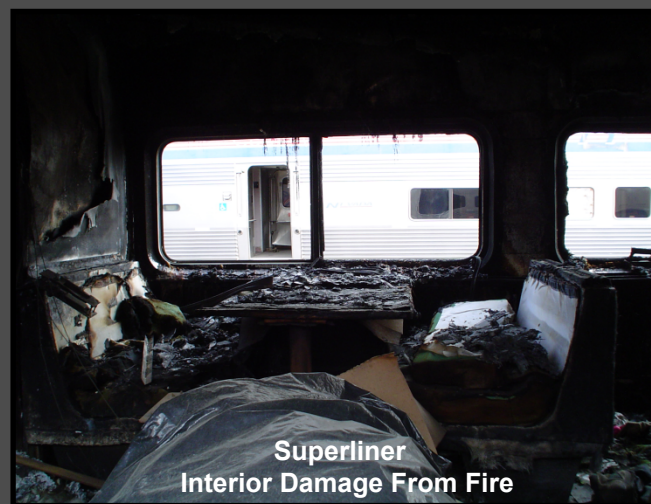
Superliner
Interior Damage From Fire

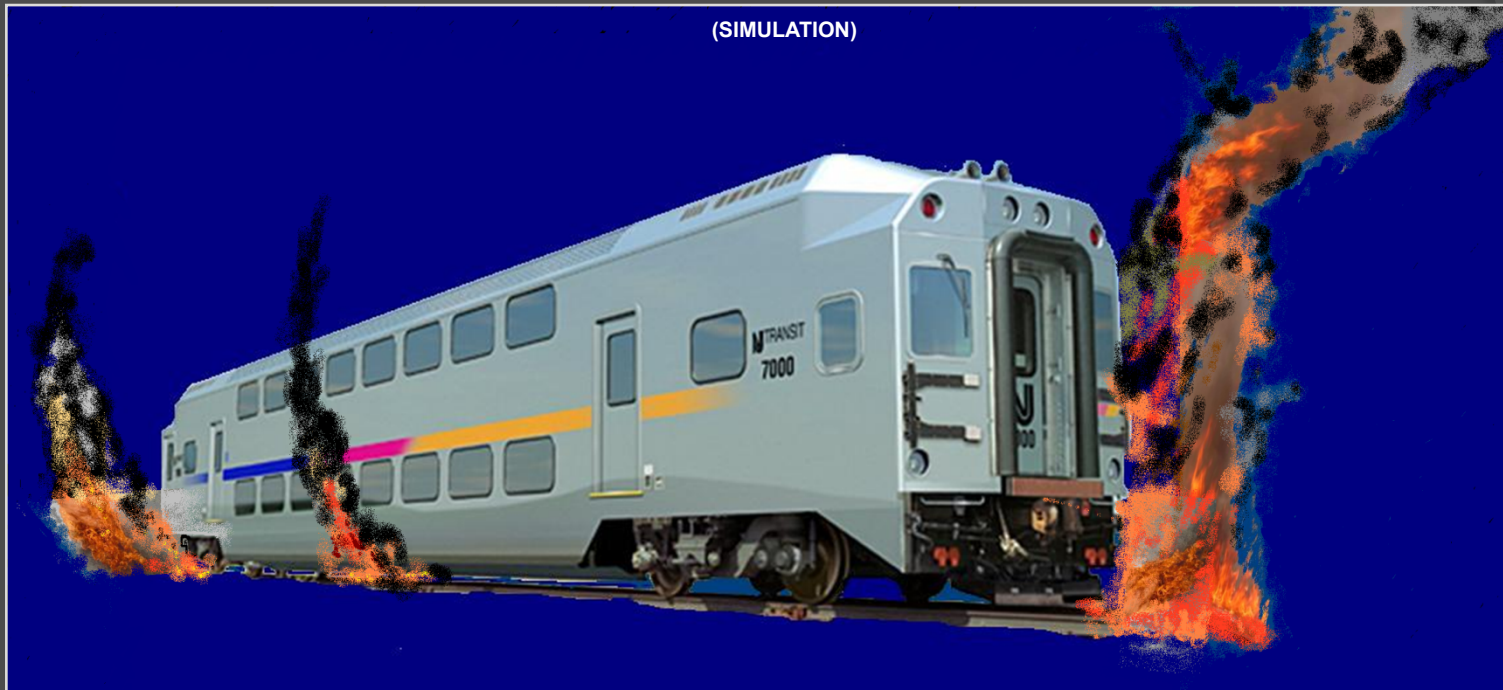
ASTM E-119 Floor Fire Endurance Test Simulates a Fire Source Beneath The Passenger Railcar

**Thirty (30) Minute Duration is Intended to
Allow for Fire Rescue of Trapped Passengers,
Especially Within Tunnels**

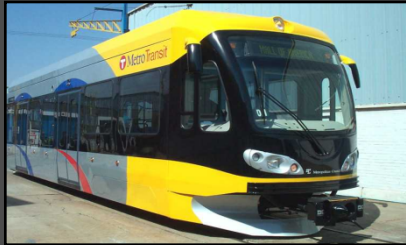
ASTM E-119 Fire Endurance Test: Bombardier Hiawatha Floor Test (Minneapolis, MN)

Test Requires Exact
Carbody Underframe be
simulated for the test.

Zone of railcar used for
this test.

Passenger Load
Density.

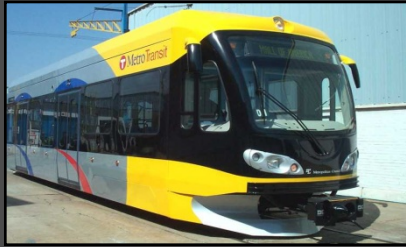
ASTM E-119 Fire Endurance Test: Bombardier Hiawatha Floor Test (Minneapolis, MN)

End View: Test Facility

Side View: Test Facility

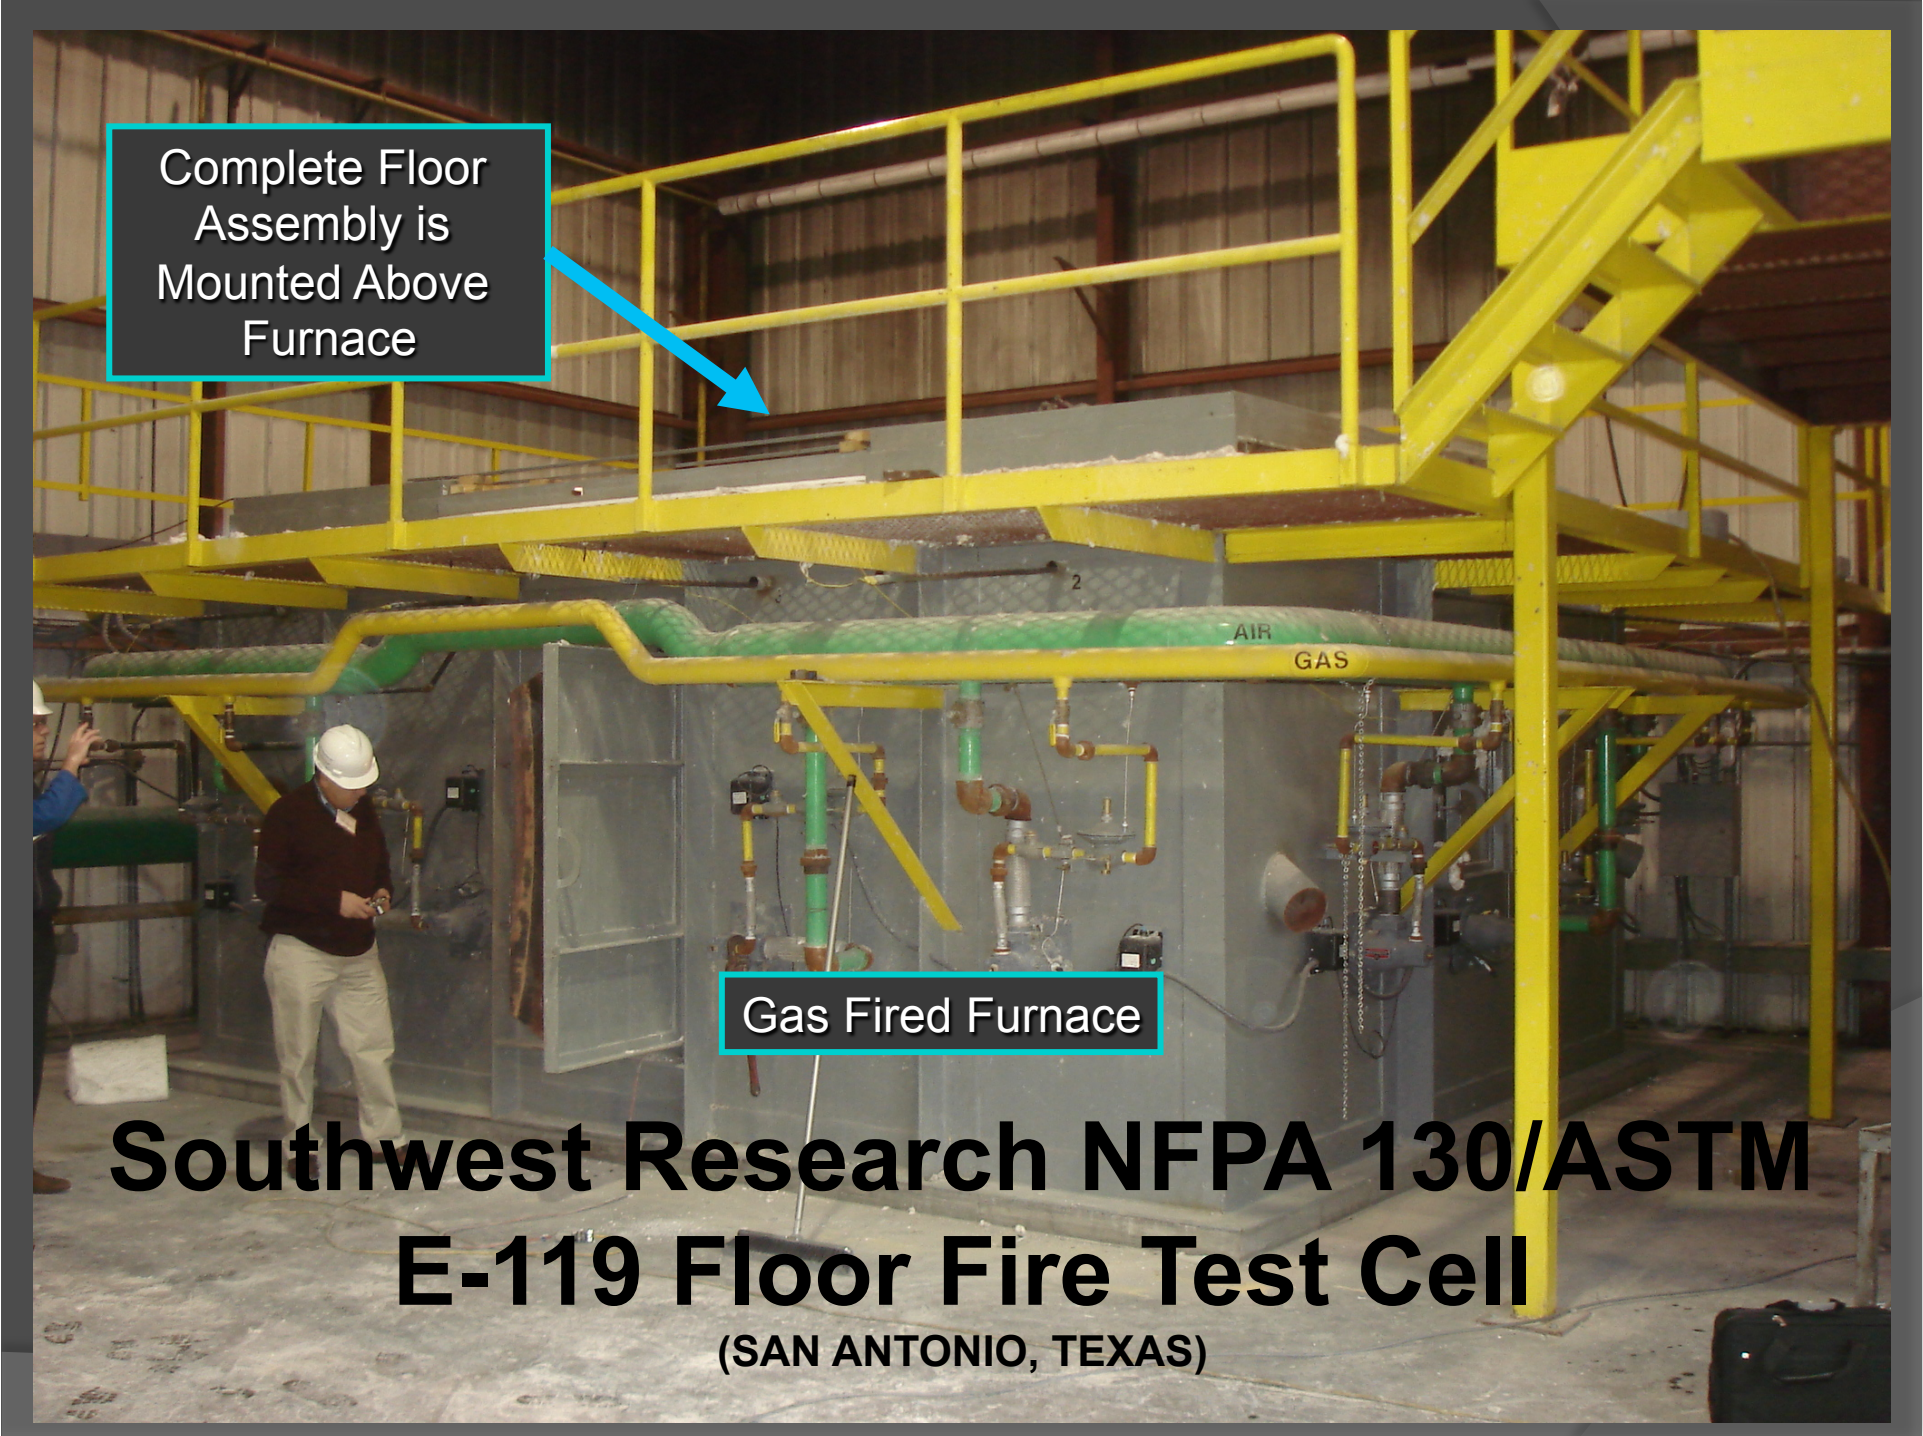
Southwest Research NFPA 130/ASTM E-119 Floor Fire Test Cell

Complete Floor
Assembly is
Mounted Above
Furnace

Gas Fired Furnace

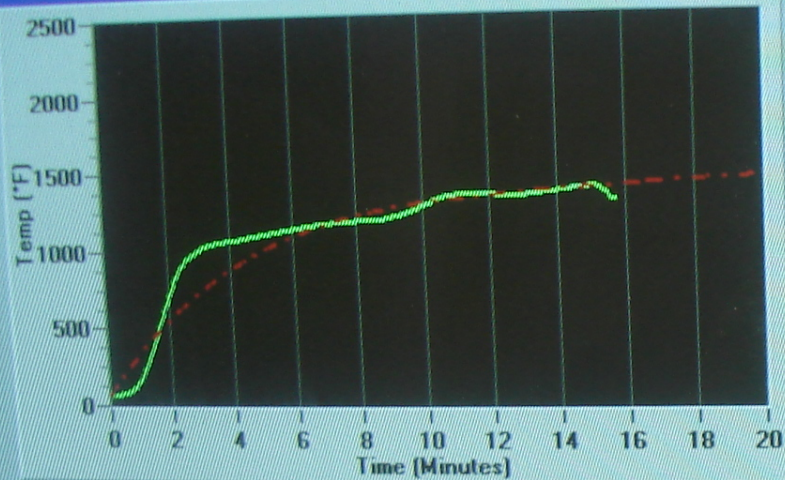
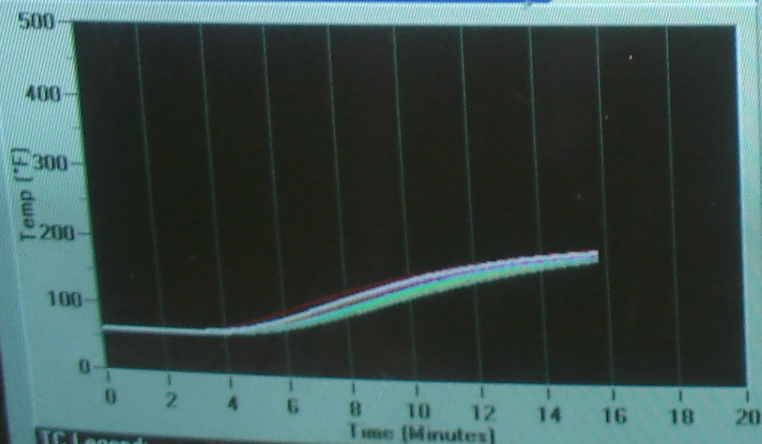
Southwest Research Institute Large Scale Furnace Test

SPECIMEN TC'S AVERAGE= 186

OK
386 °F

OK
311 °F

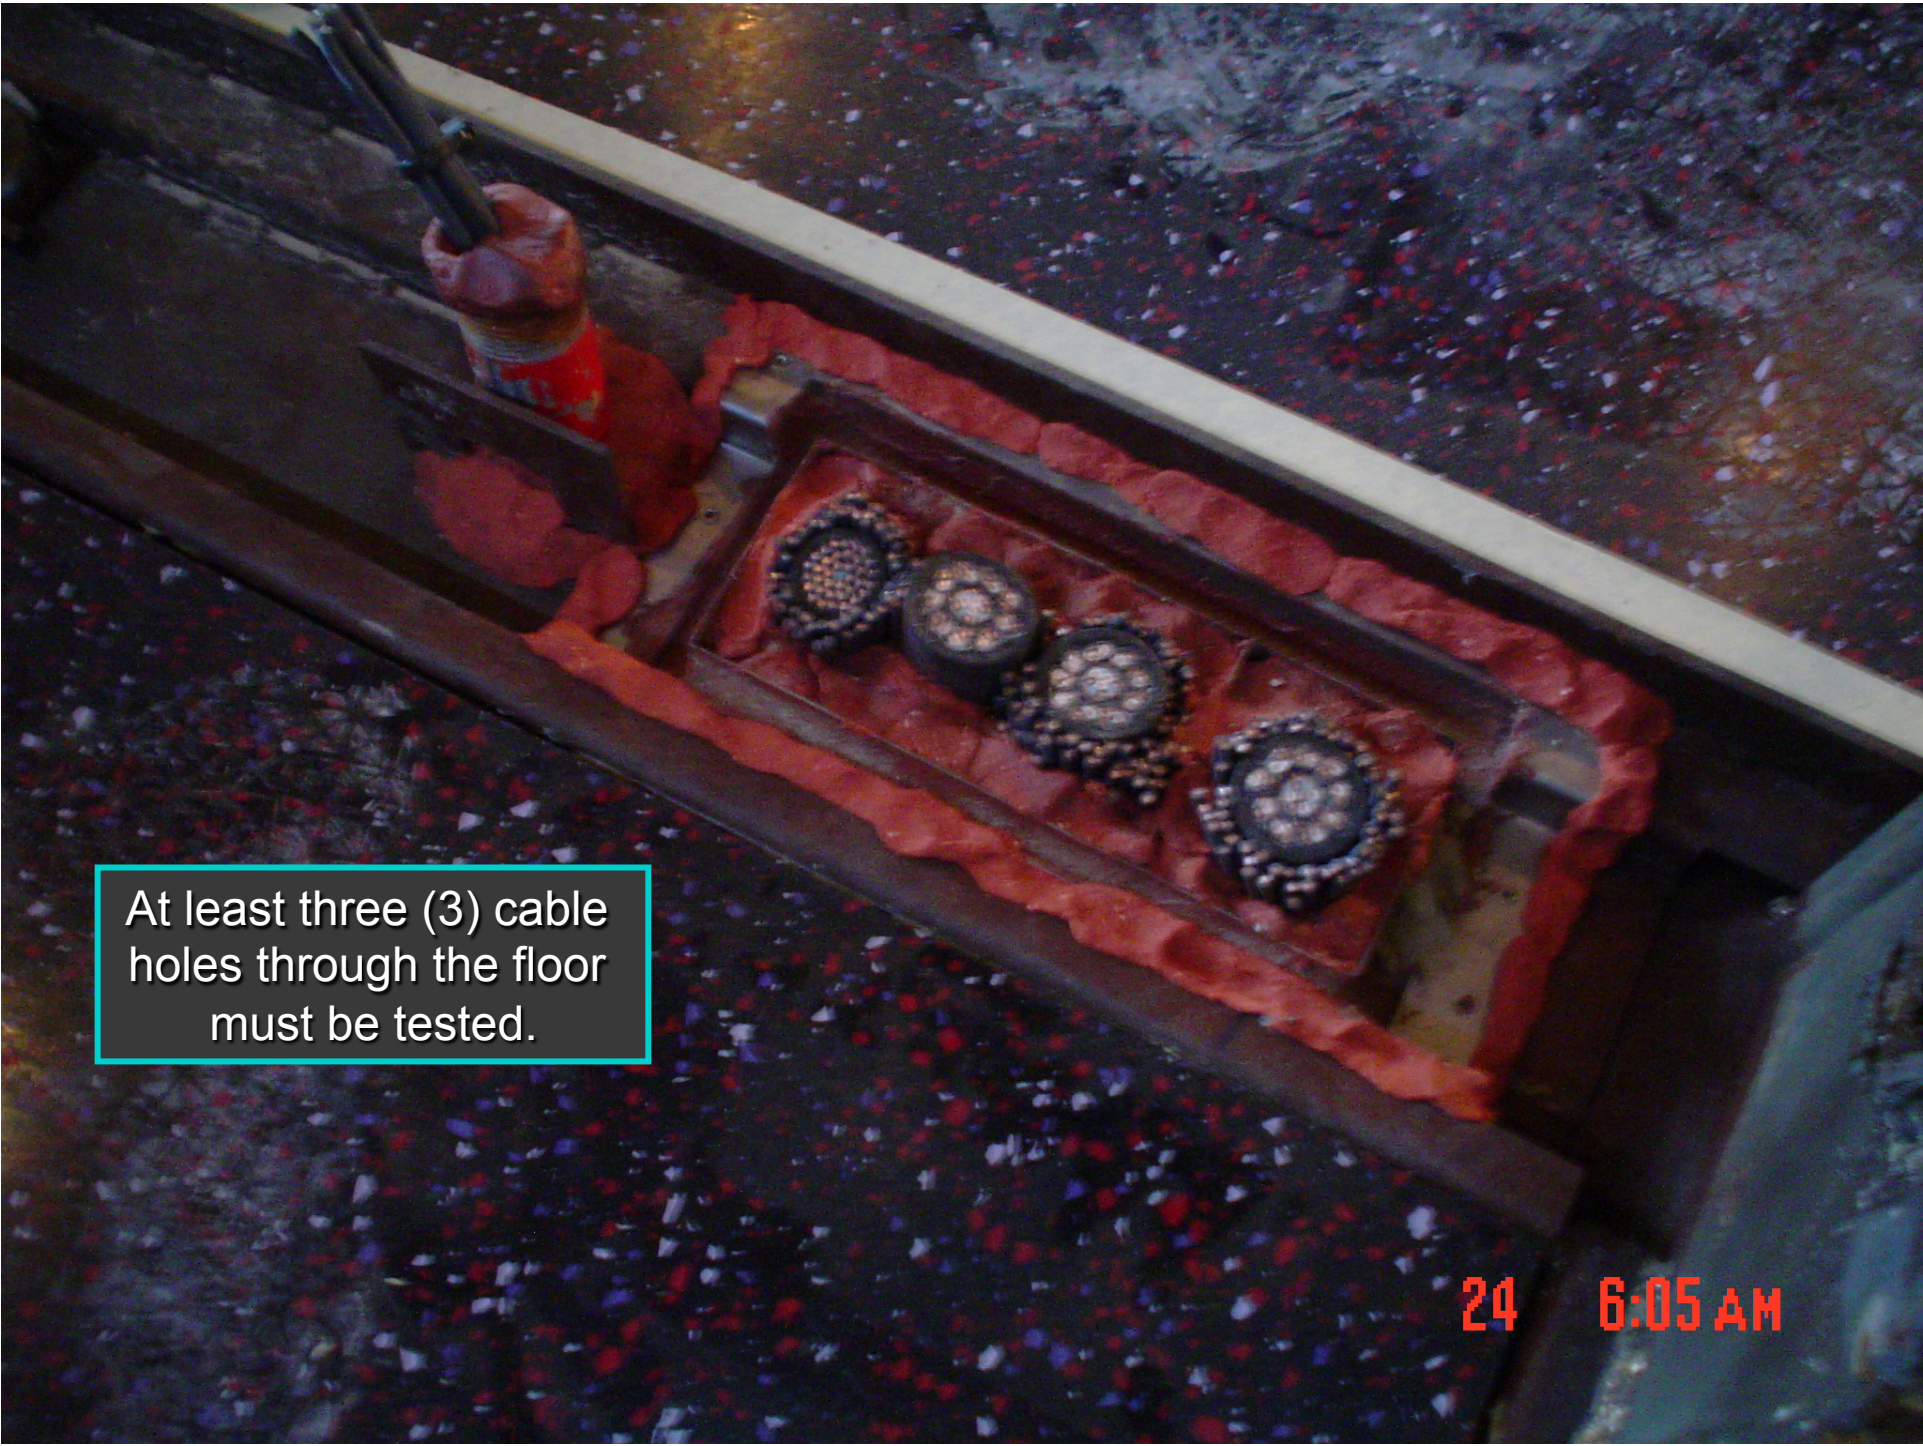
At least three (3) cable
holes through the floor
must be tested.

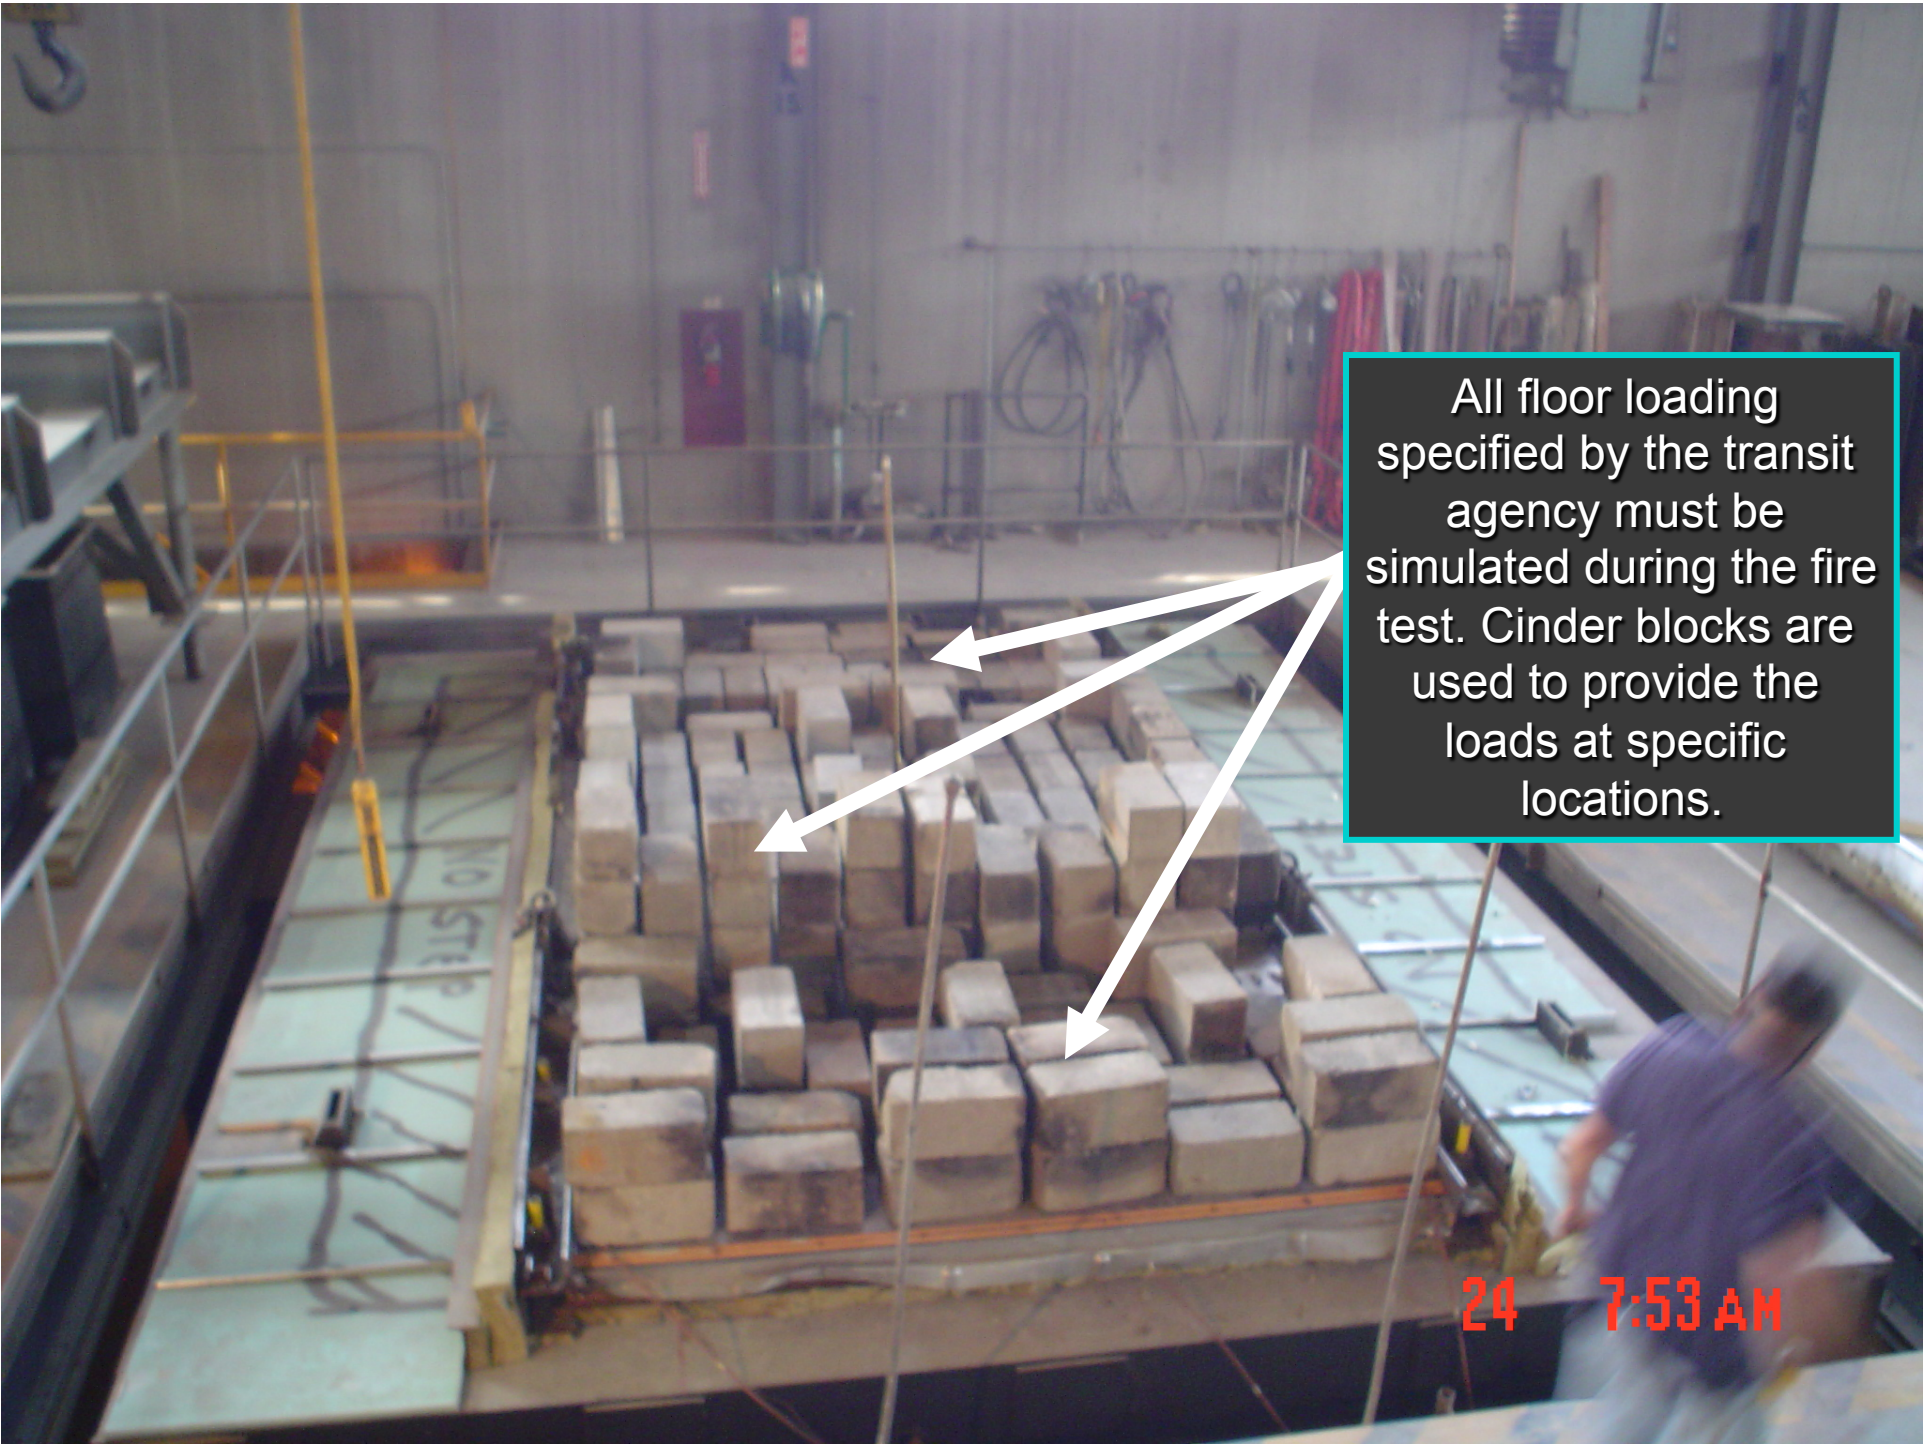
All floor loading specified by the transit agency must be simulated during the fire test. Cinder blocks are used to provide the loads at specific locations.

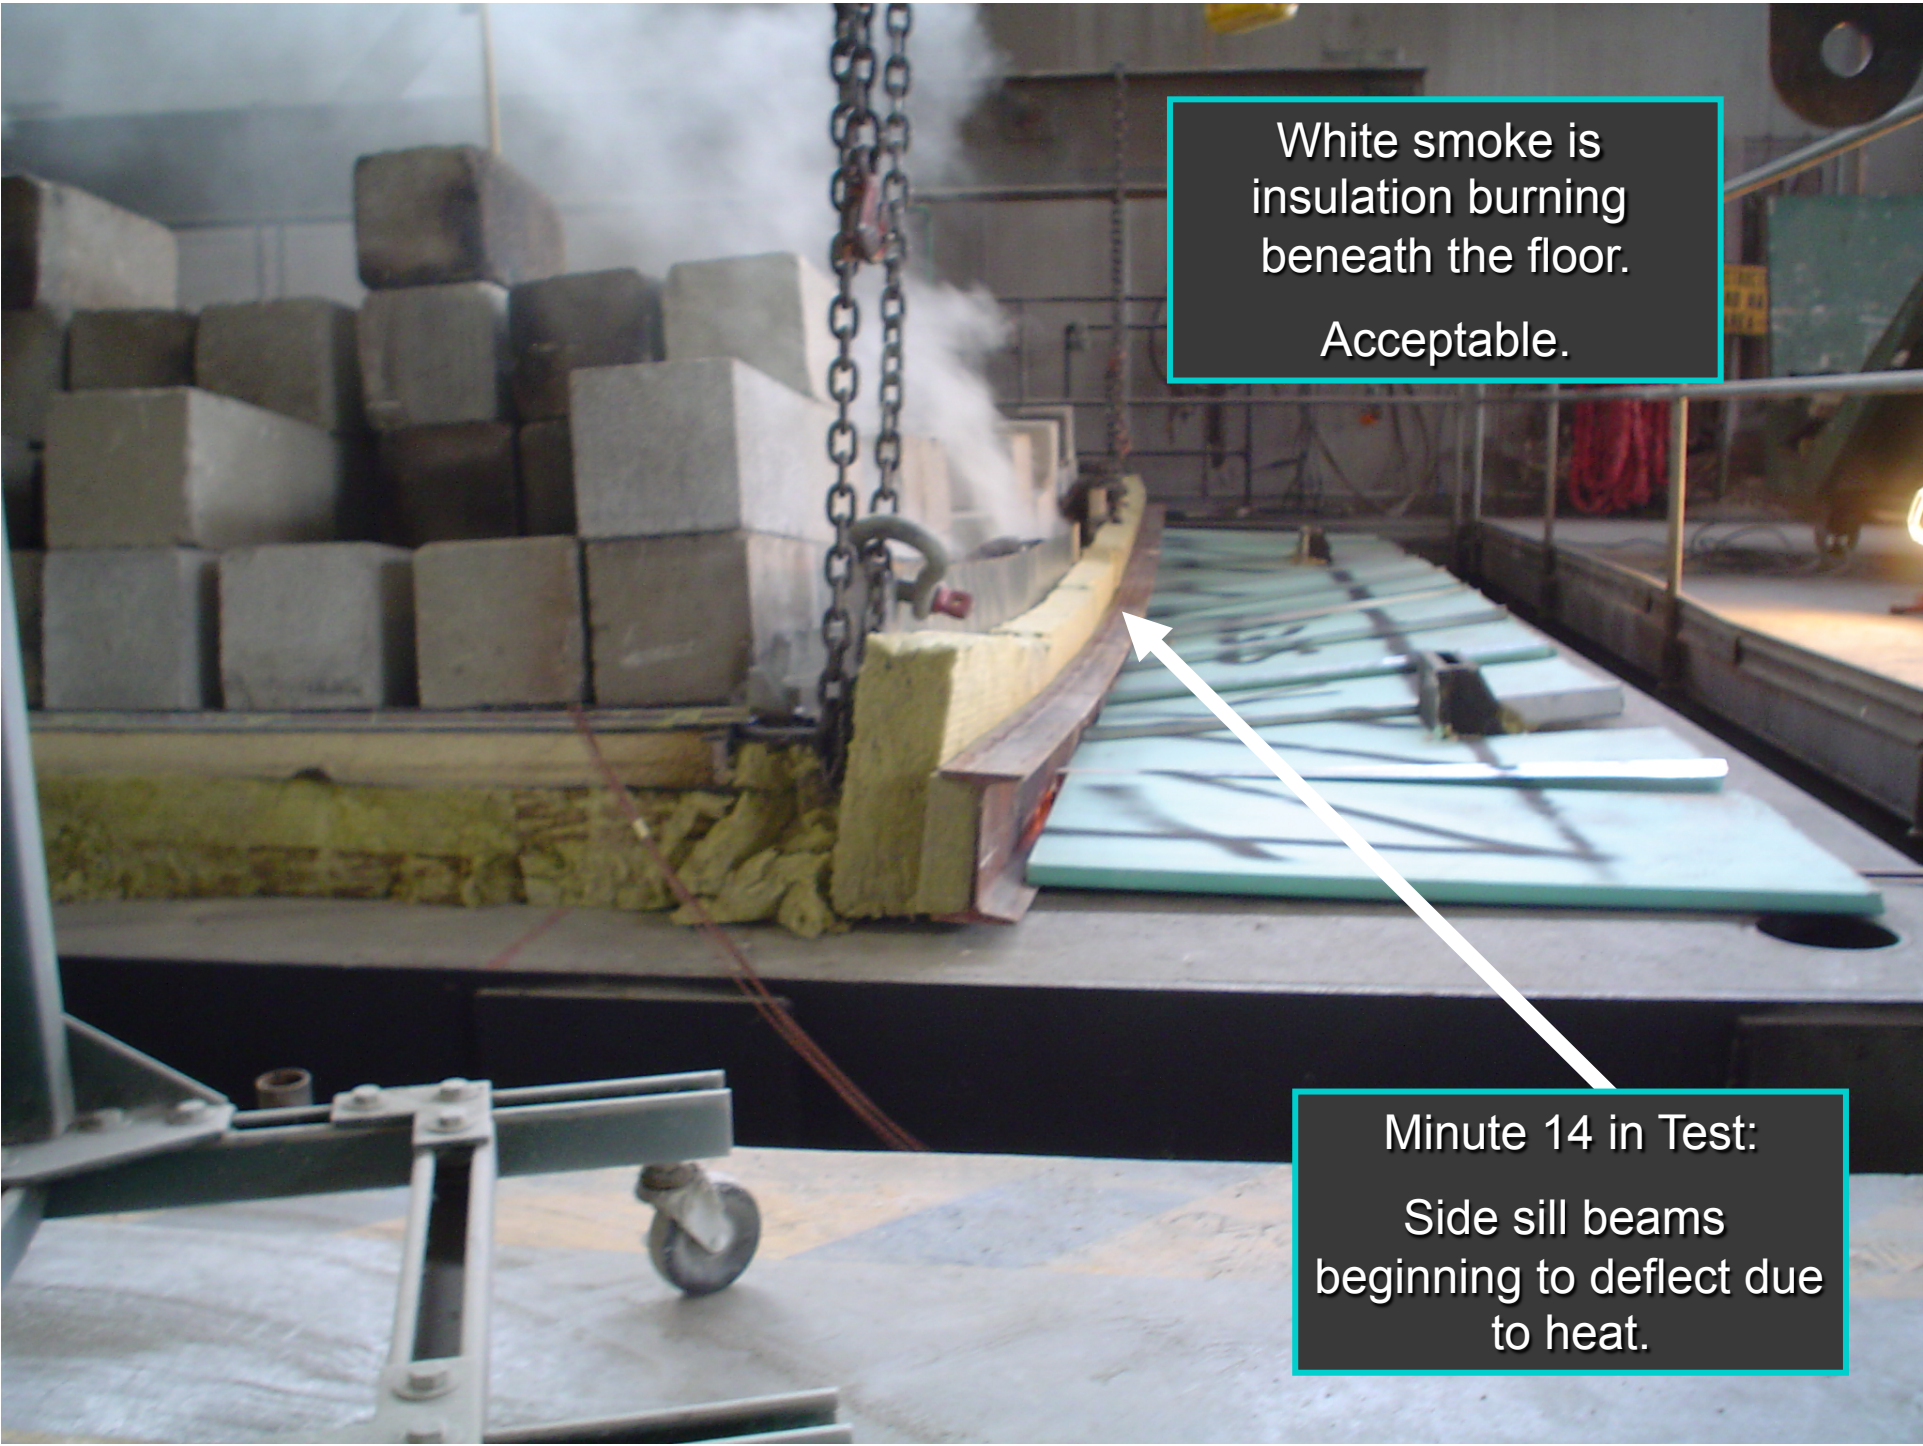
White smoke is
insulation burning
beneath the floor.
Acceptable.

Minute 14 in Test:
Side sill beams
beginning to deflect due
to heat.

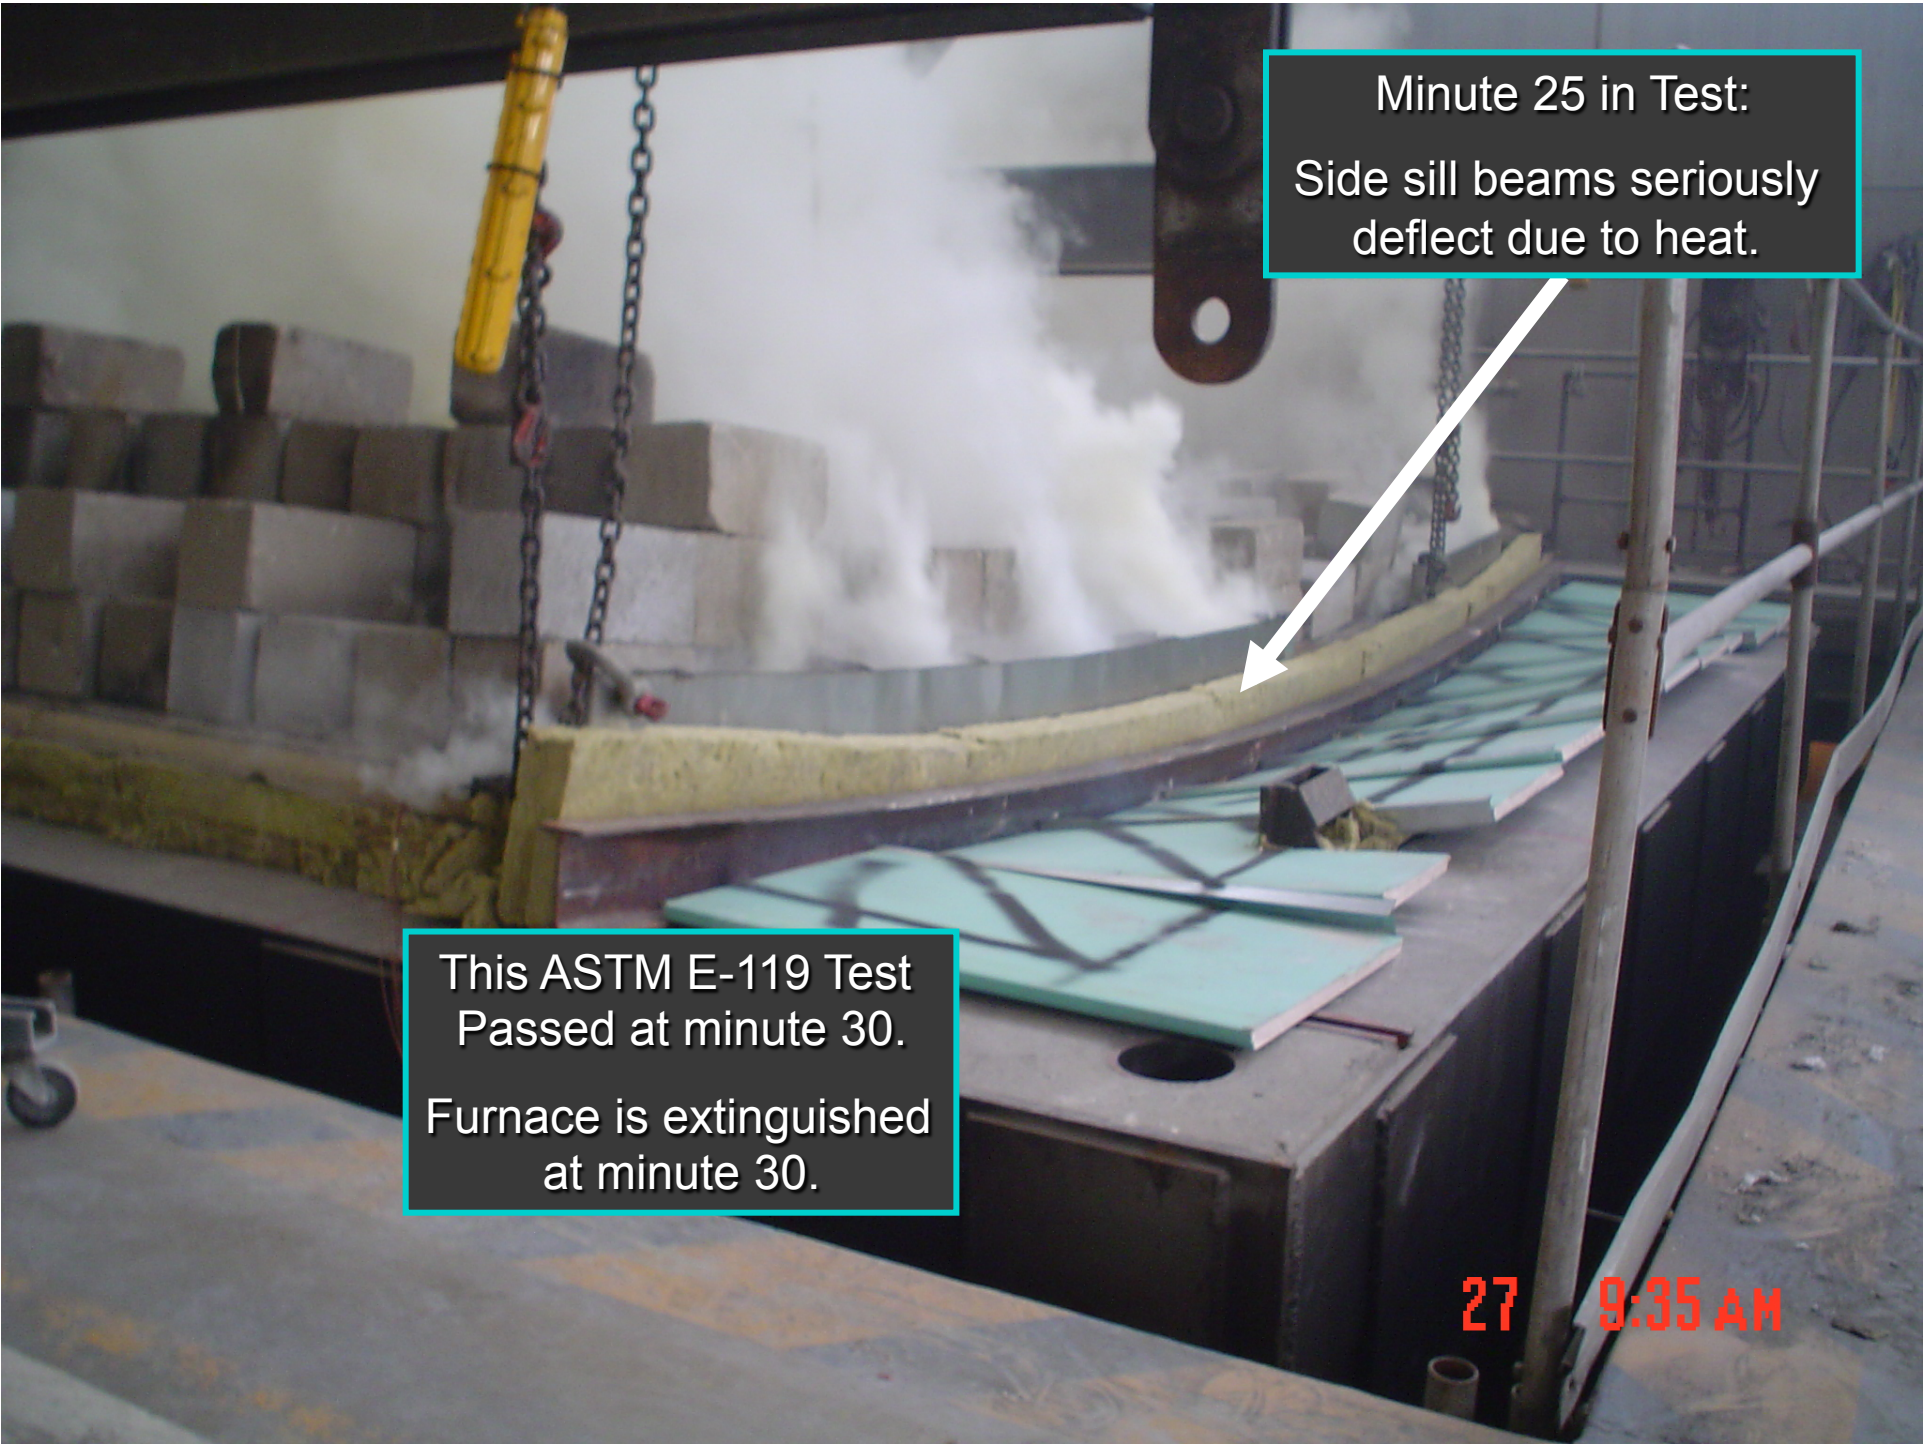
A photograph of an ASTM E-119 furnace test. A large, curved metal beam is being heated by a furnace. Thick white smoke or steam is rising from the furnace area. The beam is supported by a series of green, diamond-shaped supports. A white arrow points from the text box to the beam. The background shows a stack of concrete blocks and a yellow lifting device.

Minute 25 in Test:
Side sill beams seriously
deflect due to heat.

This ASTM E-119 Test
Passed at minute 30.
Furnace is extinguished
at minute 30.

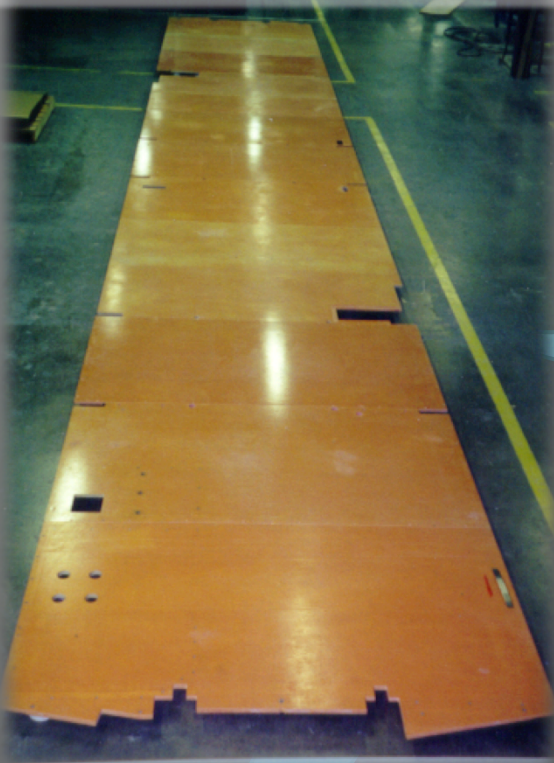
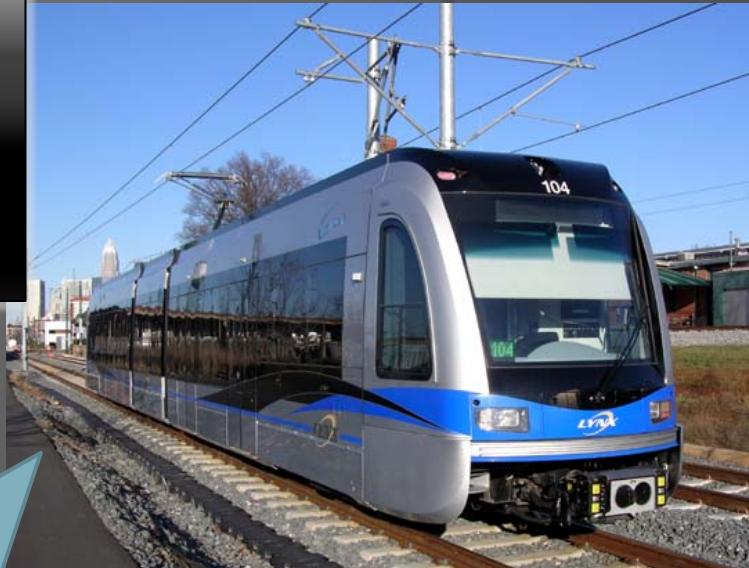
CHARLOTTE, NORTH CAROLINA

**Two Examples of USA
Composite Floors That
Required ASTM E-119 (30
minute burn test)**

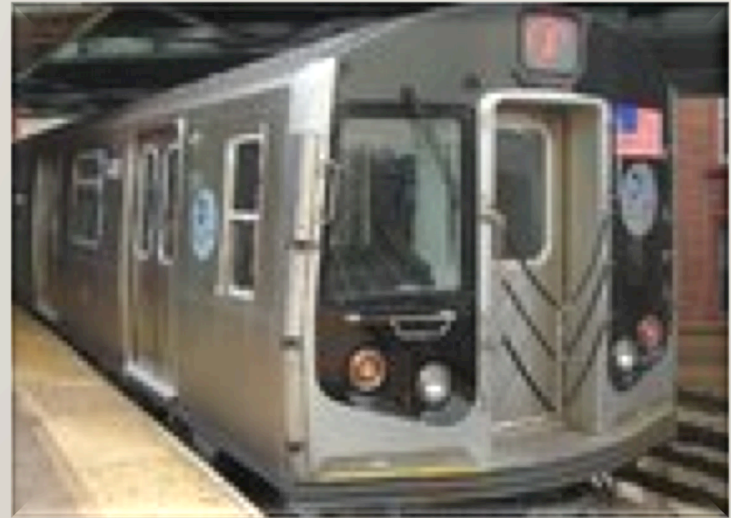
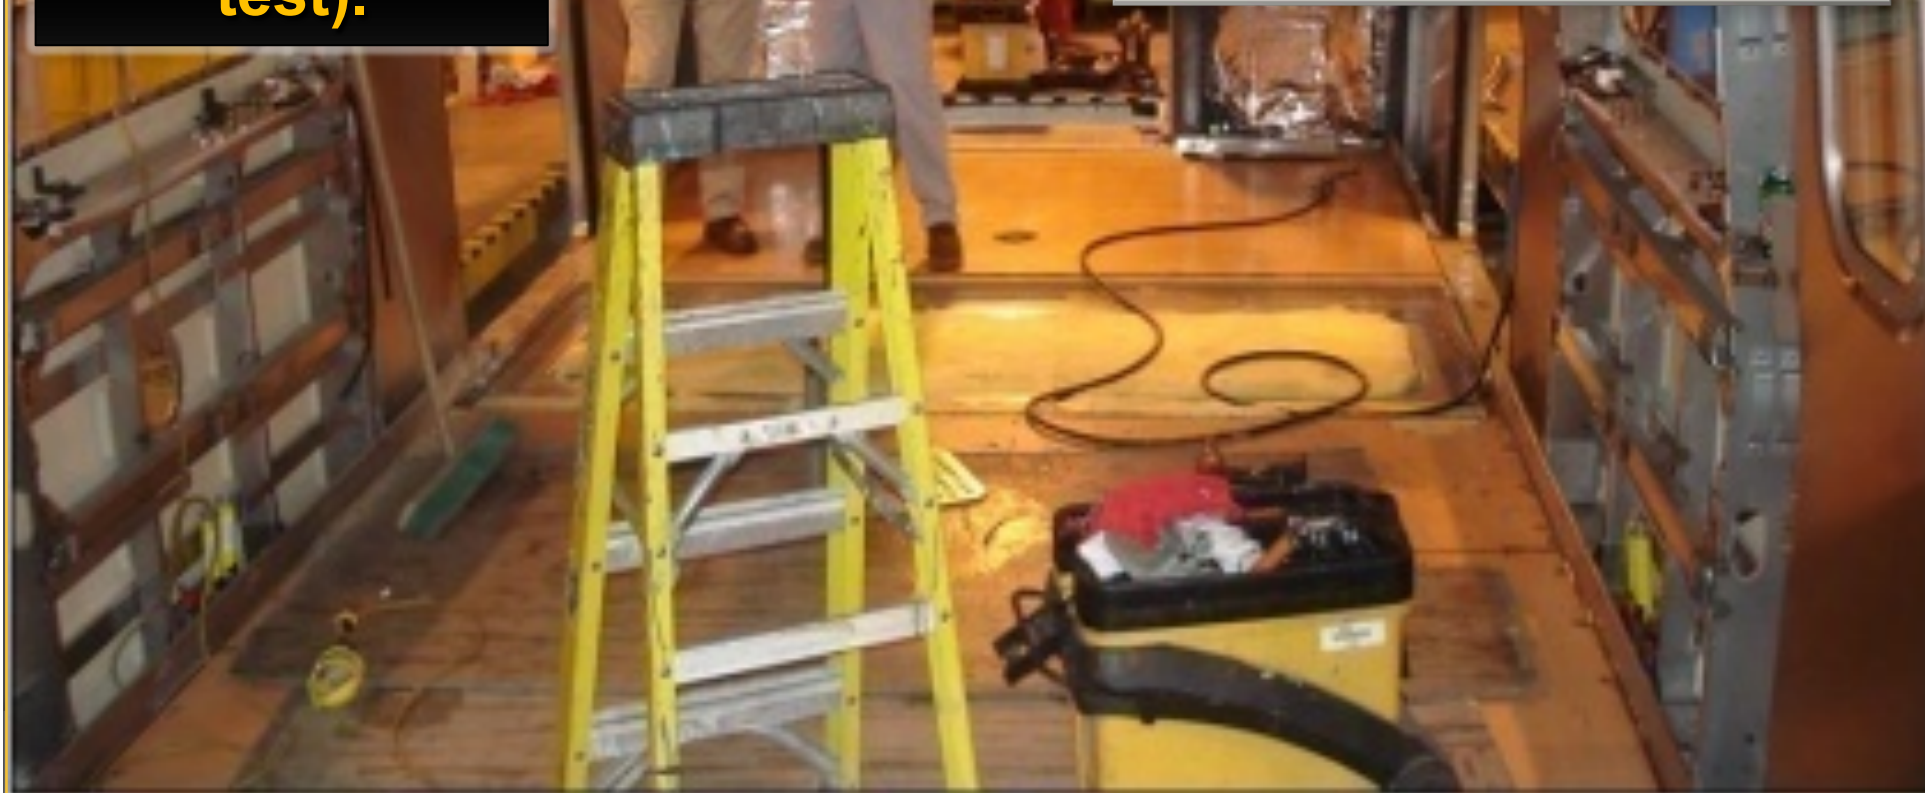
**Composite
Floors Used on
New York City
Subways also
Required ASTM
E-119 (30
minute burn
test).**

An Old Car getting new flooring to extend useful life. Had no underpan. Had to Be Revalidated.
